**EES Analysis of Candidate Apparatus with Trouble Extracted by MapSSA – H. Matsushita**

Toshiba Corporation, Semiconductor Company

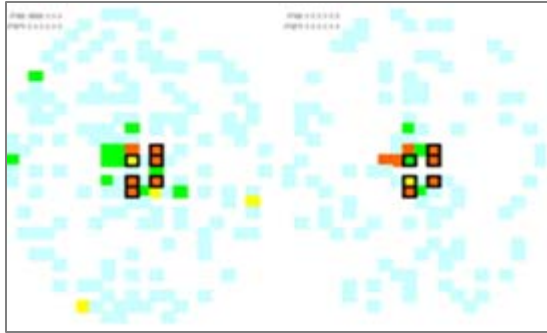
We noticed the occurrence of electrical test A – center – shot failure shown in Fig.1 detected by MapSSA. We extracted three lithography apparatus supposed to be the cause of this failure (Fig.2,

Fig.1 Wafer maps of electrical test A – center – shot failure  
We detected the occurrence of this failure by the MapSSA system.

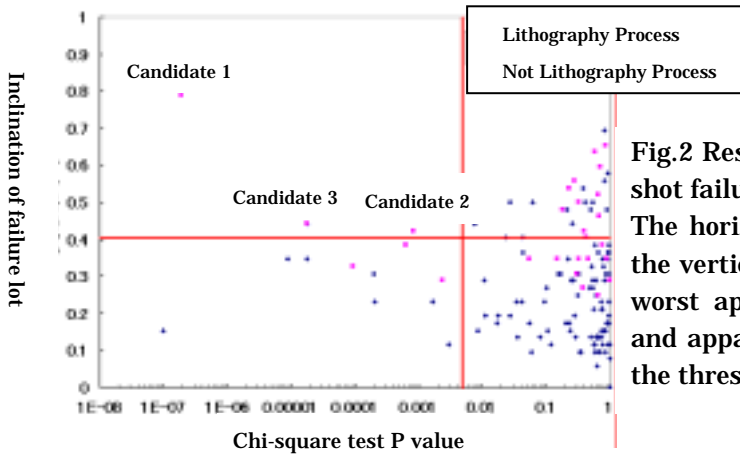
candidate 1 – 3). The shot failure occurred significantly in these lots processed with these apparatus.

Fig.2 Result of the machine difference analysis of the shot failure  
The horizontal axis is the chi-square test value and the vertical axis is the inclination of failure lot in the worst apparatus. The point represents one process and apparatus. We extracted three candidates above the threshold.

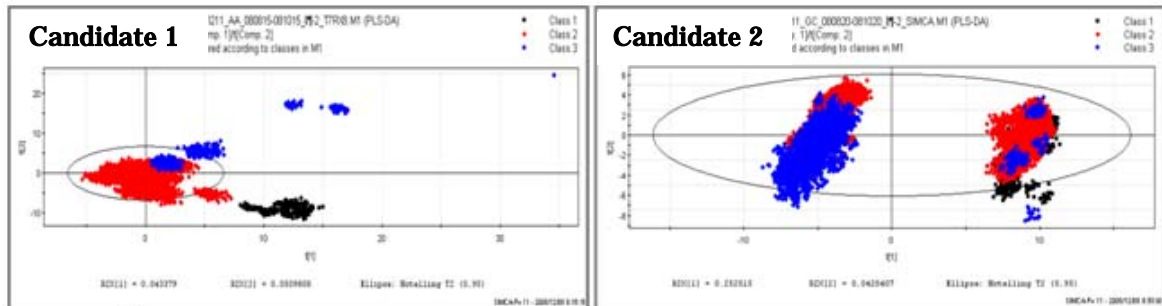
Fig.3 Result of analysis of EES data by PLS-DA

We analyzed three candidate apparatus for the shot failure by PLS-DA (Partial Least Square – Discriminant Analysis). Fig.3 shows the result. In candidate 1, primary and secondary principal components clearly separated according to normal and abnormal lots. On the other hand, in candidates 2 and 3, there is no significant difference between normal and abnormal lots. One notices that there is a right and left separation in candidate 2. However, this change in the apparatus is irrelevant to the failure. From these results, we concluded that candidate 1 is the true root cause of the shot failure. Then, we set the SPC (Statistical Process Control) rules for these parameters to detect the shot failure (Fig.4).

The horizontal and vertical axes are primary and secondary principal components, respectively. The black, red and blue plots represent normal, abnormal and after measures, respectively. In the case of candidate 1, we extracted the change of the apparatus related to the failure. However, in the case of candidate 2, the left and right separation is irrelevant to the failure.

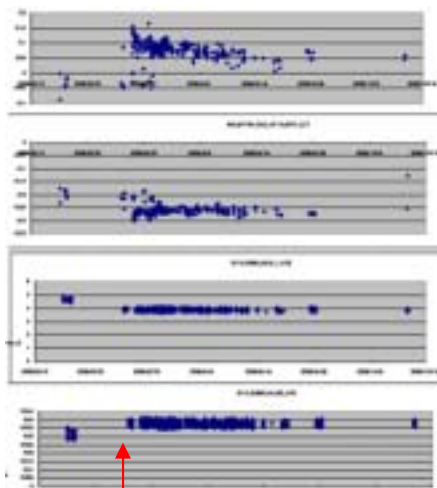
Fig.4 Result of the trend of the parameters related to the failure  
We specified four parameters for the cause of the shot failure. We monitored these parameters to detect the shot failure.
