Improving Root Cause Analysis Accuracy Using Advanced Sensor Trace Analytics

BISTel America

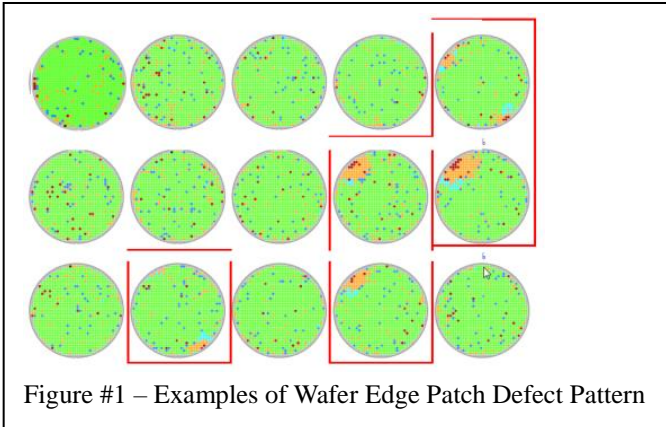
In the highlighted case study, over 30% of the wafers from two production lots suffered from wafer edge low yield patches at the 5 and 11 o'clock positions. Yield loss was up to 11% on each affected wafer (see Figure #1).

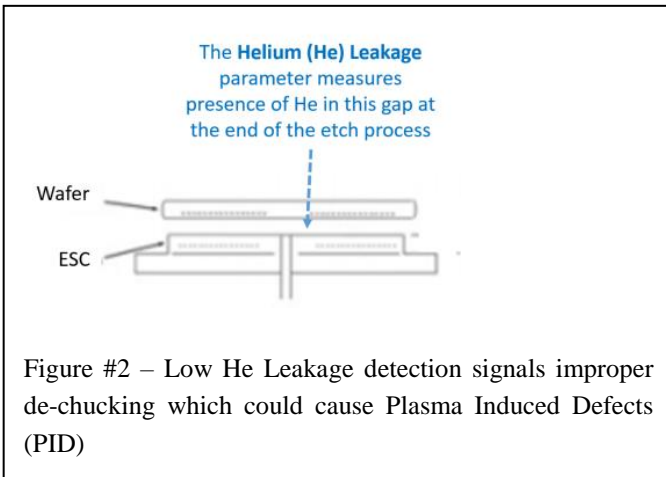
parameter level. In examining the top candidates, the engineer quickly identified that the Helium (He) Leakage parameter to be the root cause of the problem. This parameter measures the level of Helium that is present between the wafer and the ESC platform at the end of the etch process. He noticed that the measurements of this specific parameter from the low yield wafers were consistently lower than those from the high yield wafers. This indicates that the wafers were not properly decoupled from the ESC platform at the end of the process which likely resulted in Plasma Induced Defects (see Figure #2). This confirms the engineer's initial suspicion of an arcing issue.

With the confirmed root cause, the failed ESC was replaced. Both parameters are now included as part of the critical parameter list in FDC for monitoring which should prevent the re-occurrence of the same issue.

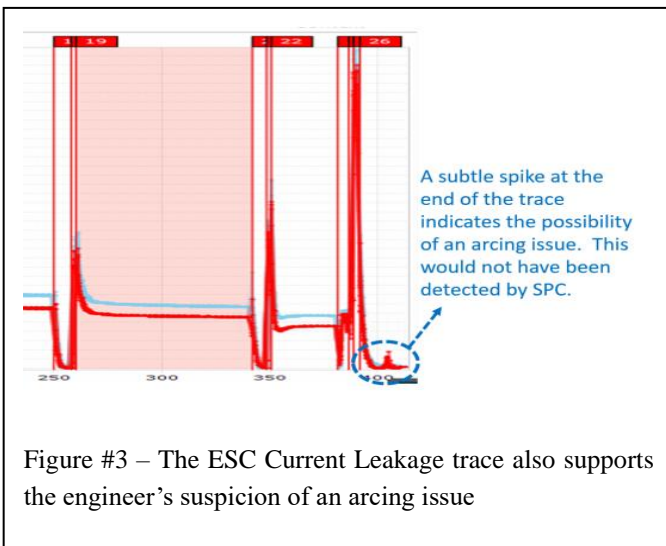
In addition, upon further examination of the rest of the parameter candidates, the engineer discovered another parameter (an unmonitored parameter by FDC) which correlated strongly with this issue. This parameter specifically measures the ESC Current Leakage, and all the traces from the affected wafers showed a subtle spike at the end of the trace which indicates abnormalities at the end of the etch process. In normal operation, this signal should be at zero at the end of the etch process. This subtle spike further supported the arcing suspicion concluded by the early finding (see Figure #3).
